Flood Control Project Maintenance
2020 Structure Summary Report
Overall Unit and Item Ratings

Lower San Joaquin Levee District

Ash Slough Drop Structure No. 1

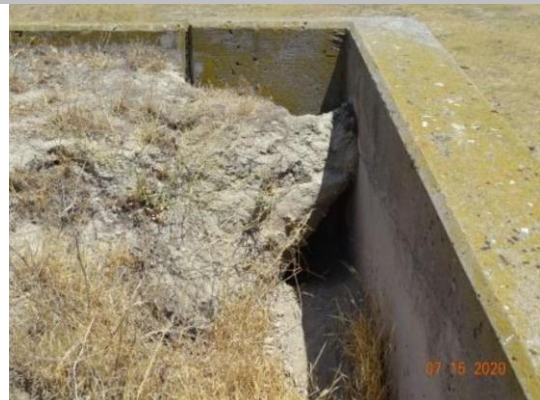
Photo 1 of 2 : ST_2020_NA0010_24_4_20200721_00015.jpg

LM Start	0.00	Rating **	A	Issue No.	4
LM End	0.00	Issue Type +	Ma	Location *	
Category	Structures & Concrete Lined Channels	GPS Latitude/Longitude			
		Start		End	
Item	Erosion / Bank Caving	37.033952 °		37.033952 °	
		-120.441733 °		-120.441733 °	
DWR ID	DWR_NA0010_24_t_2017_4				
Action/Comments					
Inspector Comments: Some minor erosion or animal burrowing was found on the back side of the right wing wall of the structure.

Minor erosion at right wing wall. (2020)

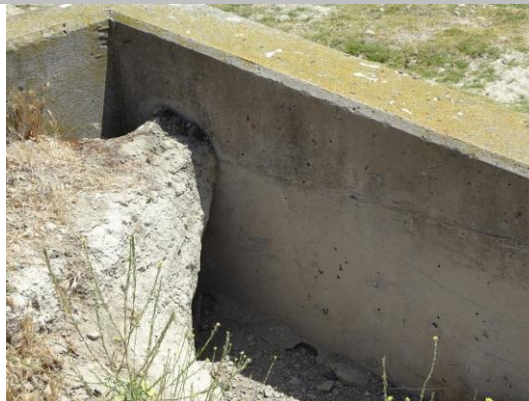
Photo 2 of 2 : ST_2020_NA0010_24_4_20200610_00006.jpg

Ash Slough #1 minor erosion at right wingwall. (Summer 2017)

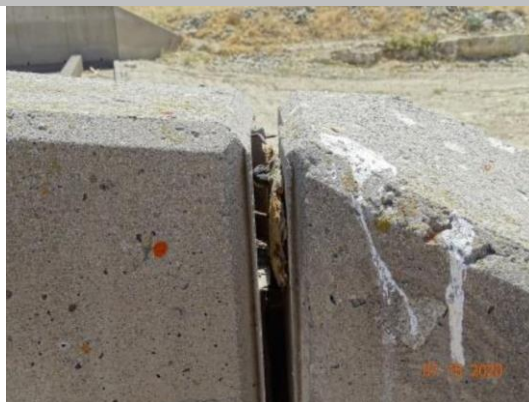
Photo 1 of 2 : ST_2020_NA0010_24_22_20200721_00018.jpg

LM Start	0.00	Rating **	A	Issue No.	22
LM End	0.00	Issue Type +	Ma	Location *	
Category	Structures & Concrete Lined Channels			GPS Latitude/Longitude	
				Start	End
Item	Monolith Joints			37.033952 °	37.033952 °
				-120.441733 °	-120.441733 °
DWR ID	DWR_NA0010_24_t_2012_22				
Action/Comments					
Inspector Comments: Joint gaskets on the wing walls appear to be deteriorating. Monitor for potential repairs.

View of gasket on the right wing wall. (2020)

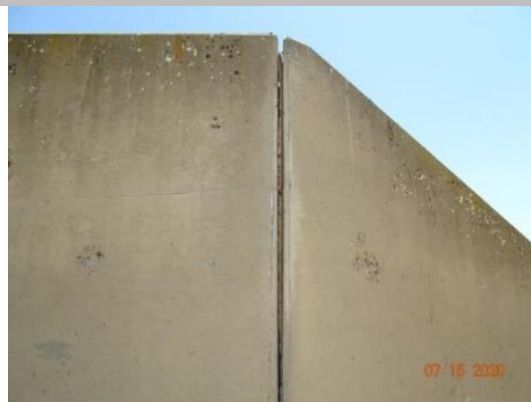
Photo 1 of 3 : ST_2020_NA0010_25_22_20200721_00022.jpg

View of the gasket at the left wing wall. (2020)

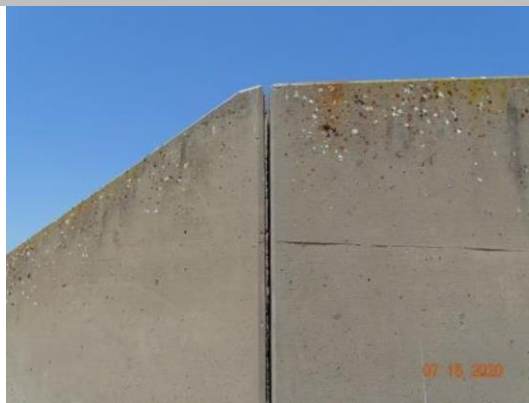
Photo 2 of 3 : ST_2020_NA0010_25_22_20200721_00023.jpg

Deteriorated gasket on the right wing wall. (2020)

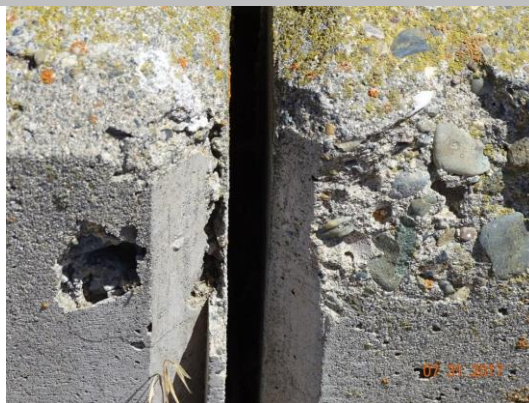
Photo 3 of 3 : ST_2020_NA0010_25_22_20200610_00011.jpg

Left bank gasket is deteriorated at headwall. (2017)

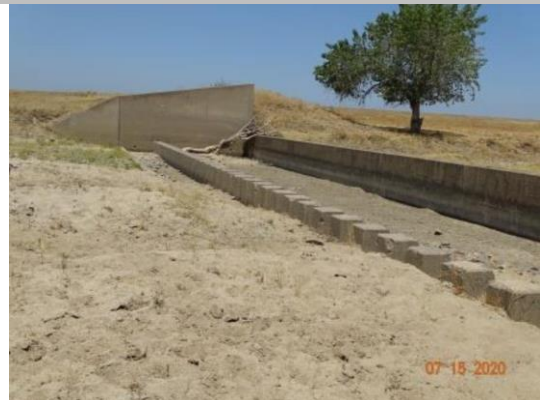
Photo 1 of 1 : ST_2020_NA0010_26_5_20200721_00016.jpg

Downstream view of revetment, mostly obscured by sedimentation. (2020)

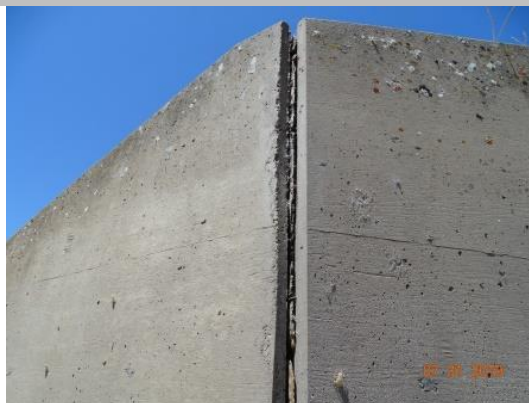
Photo 1 of 1 : ST_2020_NA0010_26_22_20200610_00009.jpg

Deterioration of right wing wall gasket. (2019)

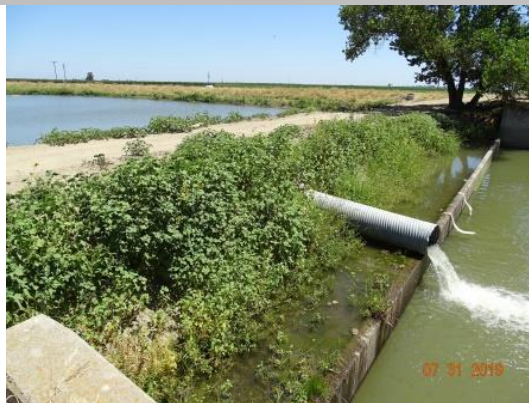
Photo 3 of 3 : ST_2020_NA0010_27_6_20200610_00010.jpg

View of unauthorized earthen dam and pipe from right bank. (2019)

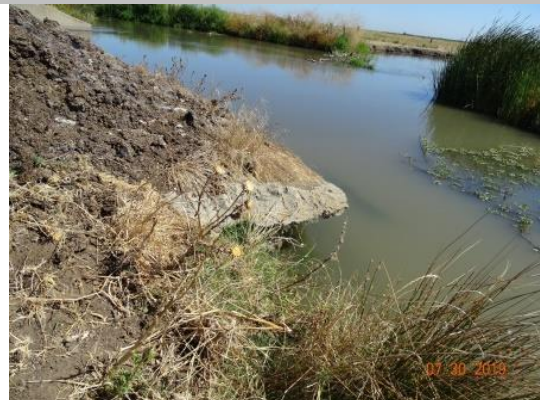
Photo 1 of 2 : ST_2020_NA0010_34_4_20200610_00004.jpg

View of erosion at left bank on the upstream side of the structure. (2019)

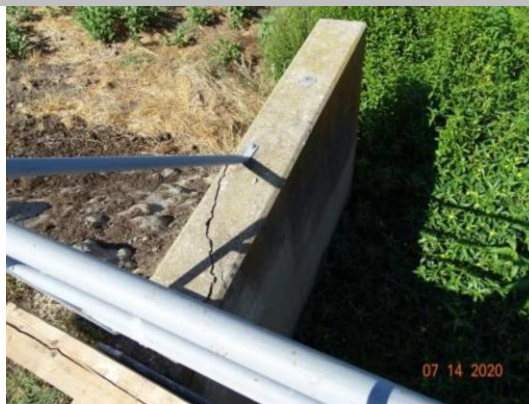
Photo 1 of 2 : ST_2020_NA0010_34_15_20200716_00028.jpg

Cracking on left wing wall. (2020)

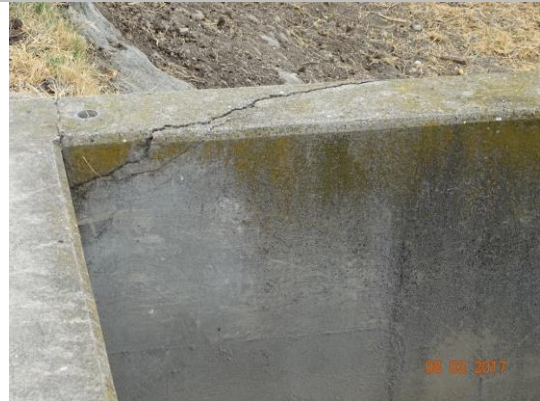
Photo 2 of 2 : ST_2020_NA0010_34_15_20200610_00012.jpg

Cracking on left wing wall. (2017)

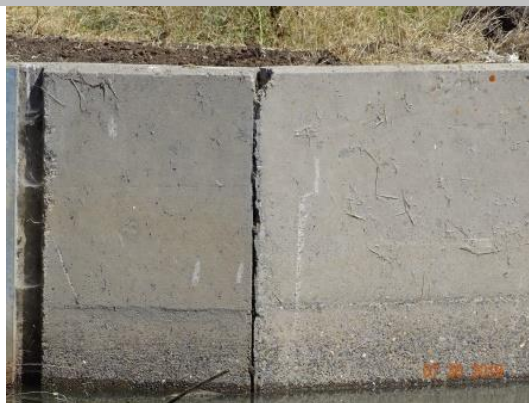
Photo 1 of 1 : ST_2020_NA0010_34_22_20200610_00017.jpg

Joint deterioration on right headwall. (2019)

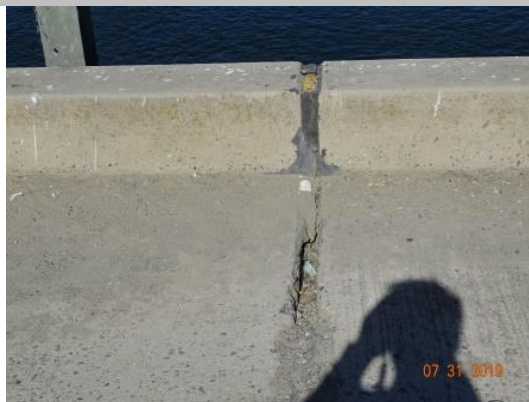
Photo 1 of 3 : ST_2020_NA0010_65_22_20200610_00008.jpg

Deterioration of joint material along top on roadway side of structure. (2019)

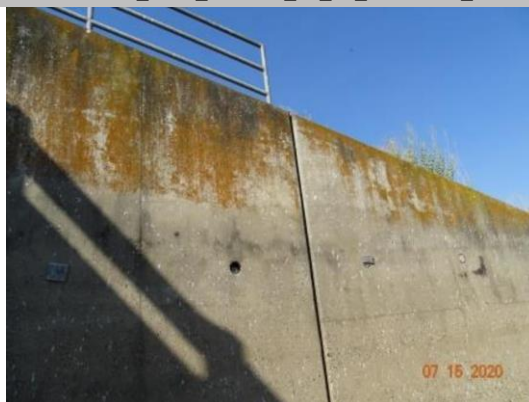
Photo 2 of 3 : ST_2020_NA0010_65_22_20200720_00016.jpg

Minor deterioration of the left wing wall joint. (2020)

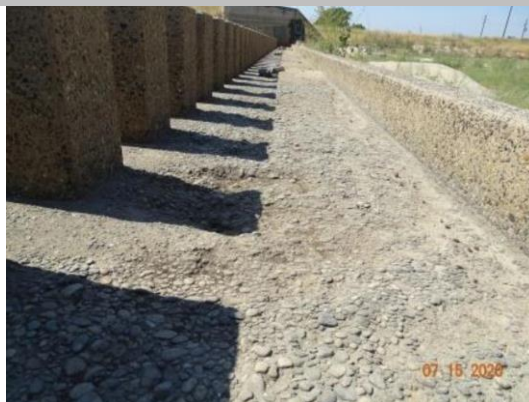
Photo 1 of 2 : ST_2020_NA0010_29_15_20200721_00021.jpg

Scour along the base concrete downstream of the dissipators. (2020)

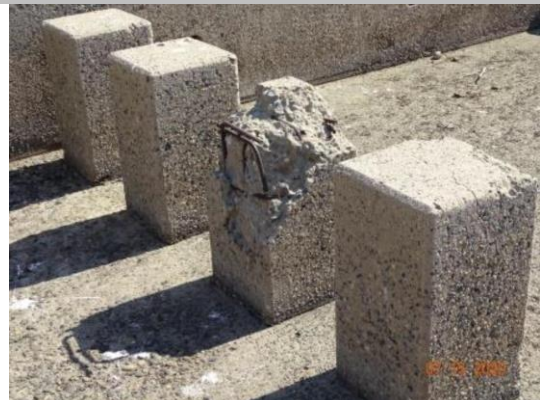
Photo 1 of 1 : ST_2020_NA0010_30_15_20200720_00016.jpg

Dissipator near right wing wall is damaged. (2020)

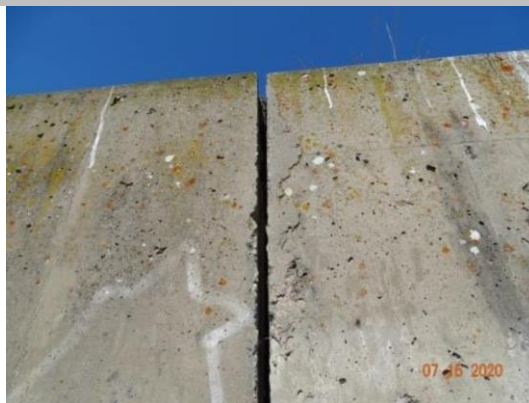
Photo 1 of 2 : ST_2020_NA0010_30_22_20200720_00017.jpg

Joint deterioration at left headwall. (2020)

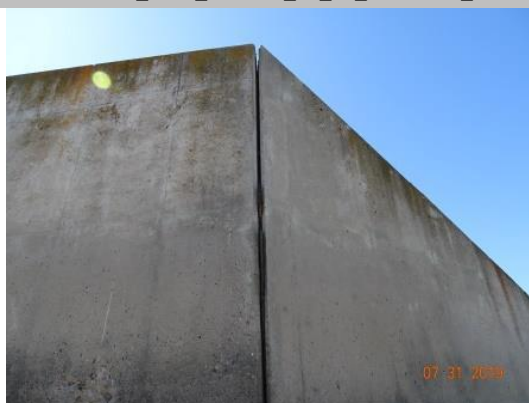
Photo 2 of 2 : ST_2020_NA0010_30_22_20200610_00009.jpg

Joint deterioration on left wing wall. (2019)

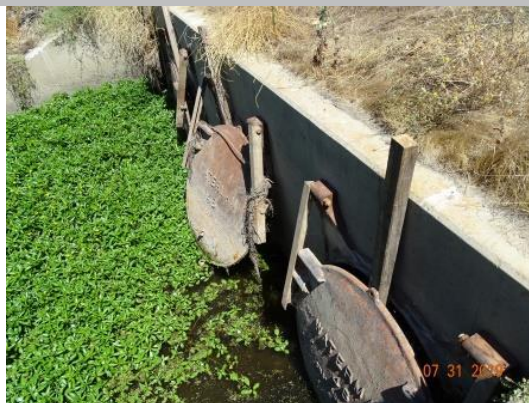
Photo 2 of 2 : ST_2020_NA0010_39_7_20200610_00006.jpg

View of outlet side of structure. Wood planks have been placed to prop open flap gates. (2019)

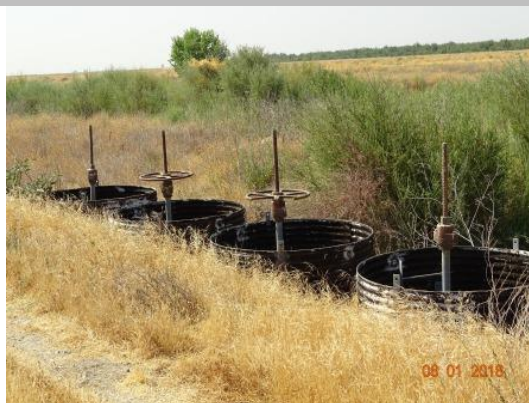
Photo 2 of 2 : ST_2020_NA0010_39_14_20200610_00010.jpg

View of missing and broken wheel handles. (2018)

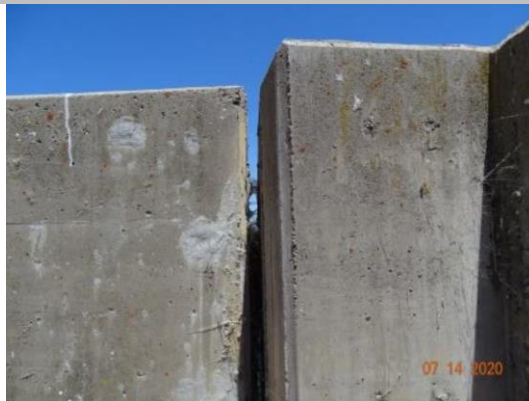
Photo 1 of 2 : ST_2020_NA0010_31_22_20200720_00012.jpg

View of the deteriorated joint at the left wing wall. (2020)

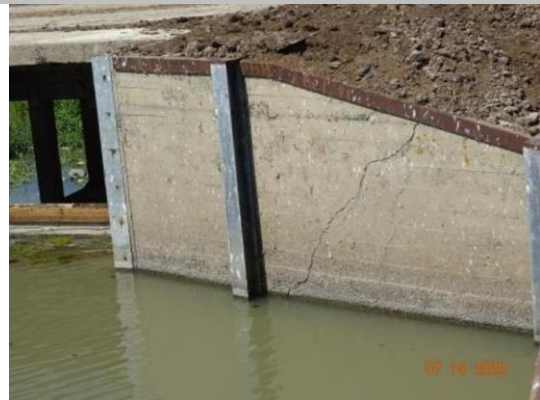
Photo 1 of 4 : ST_2020_NA0010_49_15_20200717_00022.jpg

Cracking on the right headwall of the structure. (2020)

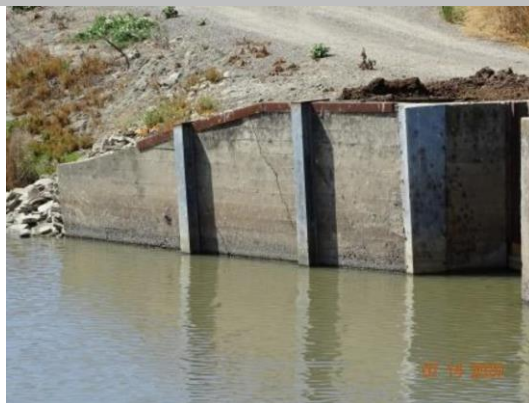
Photo 2 of 4 : ST_2020_NA0010_49_15_20200717_00023.jpg

Cracking on the left headwall of the structure. (2020)

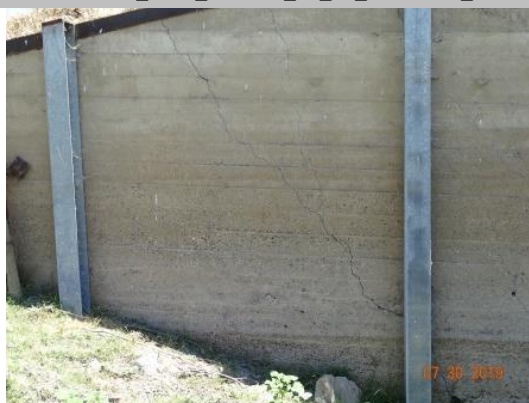
Photo 3 of 4 : ST_2020_NA0010_49_15_20200610_00008.jpg

Looking at small crack on right wing wall on downstream side of structure. (2019)

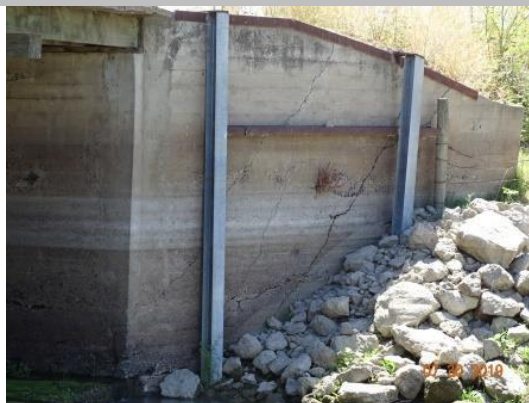
Photo 4 of 4 : ST_2020_NA0010_49_15_20200610_00009.jpg

Looking at crack on left wing wall on downstream side of structure. (2019)

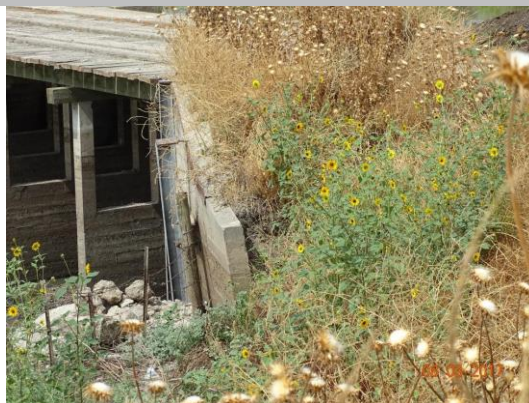
Photo 5 of 5 : ST_2020_NA0010_49_16_20200610_00016.jpg

Left wingwall tilting with braces in place. (2017)

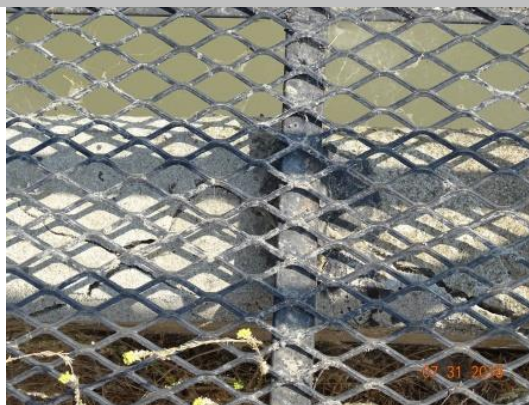
Photo 1 of 2 : ST_2020_NA0010_50_15_20200610_00008.jpg

Small cracking on the headwall. (2018)

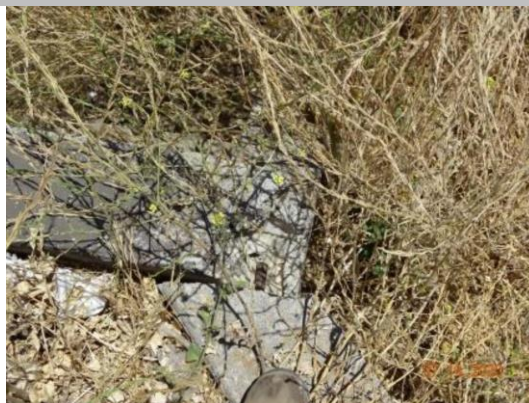
Photo 1 of 1 : ST_2020_NA0010_66_15_20200720_00019.jpg

View of cracking at the joint on the left inlet side. (2020)

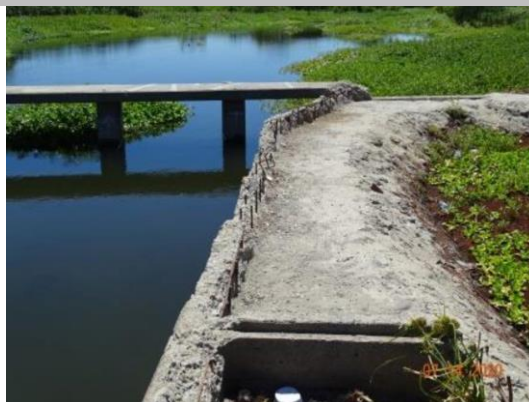
Photo 1 of 3 : ST_2020_NA0010_67_15_20200720_00009.jpg

Damage to the left wall of the structure. (2020)

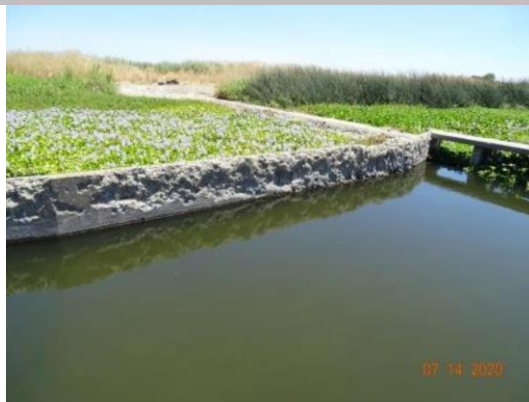
Photo 2 of 3 : ST_2020_NA0010_67_15_20200720_00010.jpg

Exposed rebar along the right Parshall flume wall. (2020)

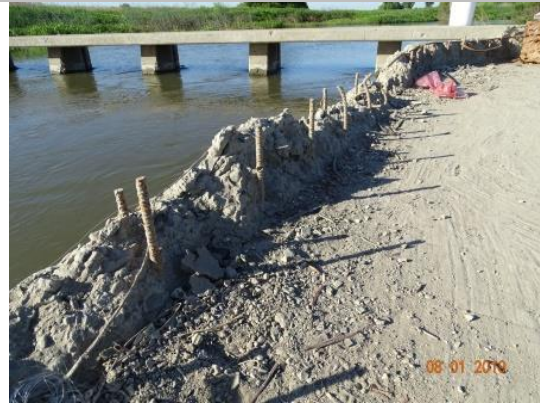
Photo 3 of 3 : ST_2020_NA0010_67_15_20200610_00003.jpg

Damage to left wall of structure. (2019)
